Building Inspection Report

| Property Inspected: | <Address> |

In accordance with your instructions, the single family residence located at <Address>, <City>, was inspected on <Date>. The inspection consisted of a visual examination of the structure. No destructive or environmental testing was performed, nor were any walls or ceilings opened for inspection where access was not already in place. Septic tanks, common areas, or other concealed structures are specifically excluded from the inspection.

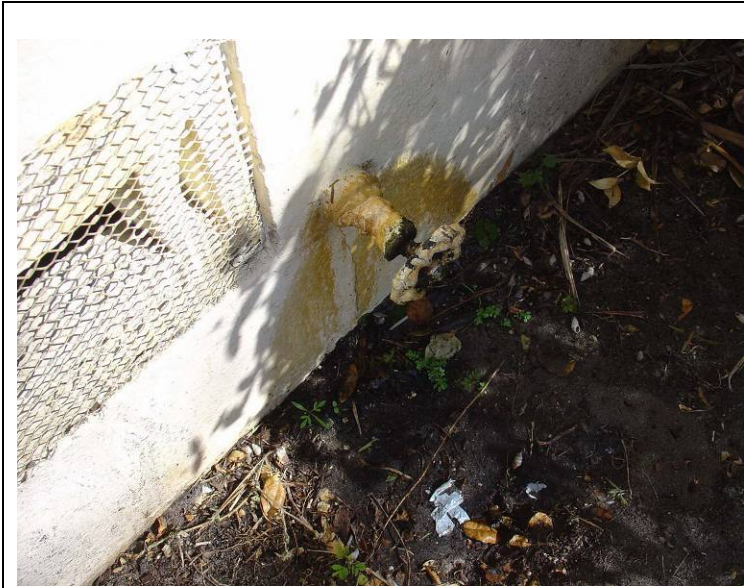
1

Main water supply shutoff valve.

3. Replace the south exterior hose connection valve handle. Replace the main water supply shutoff valve handle. 90.00
4. The water heater pressure relief line is not installed. The pressure relief line should terminate outside the structure. 125.00

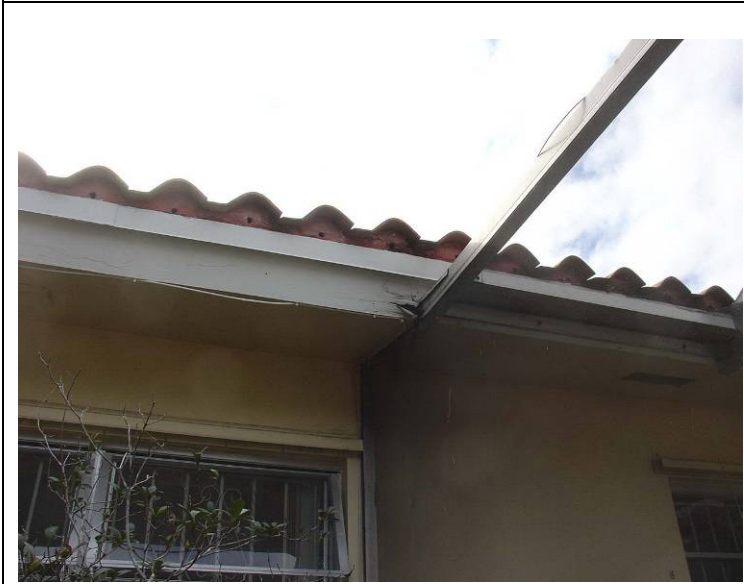
2

11. The atrium enclosure screens are torn or missing. 550.00
12. The fascia is damaged in several locations as a result of water penetration and termites. The termite damaged areas have been concealed with painting. Replace all damaged sections. 750.00

Damaged fascia and atrium screen enclosure.

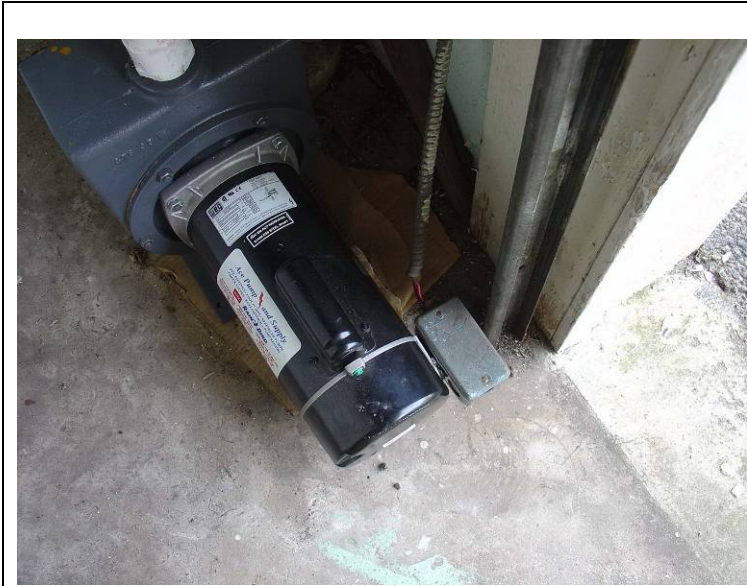
3

4. The exposed wires connected to the a/c condenser should be in protective conduit. 90.00
5. The exposed wires connected to the sprinkler pump need to be concealed for safety. 90.00

Exposed wires at sprinkler system pump.

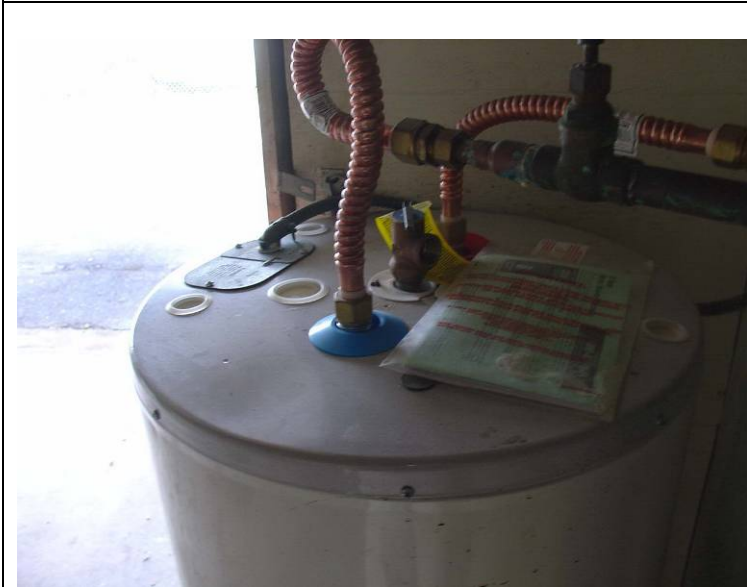
4

Missing water heater pressure relief line.

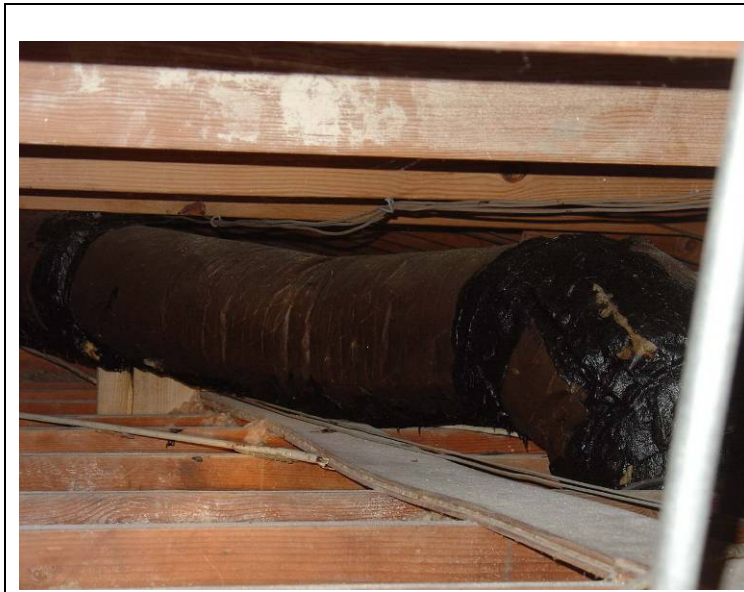
7

1. The sheet metal ducts should be replaced as excess condensation may lead to corroded ducts. The corroded metal particles can then be dispersed throughout the residence and pose a potential health hazard. 1750.00

Insulated sheet metal duct.

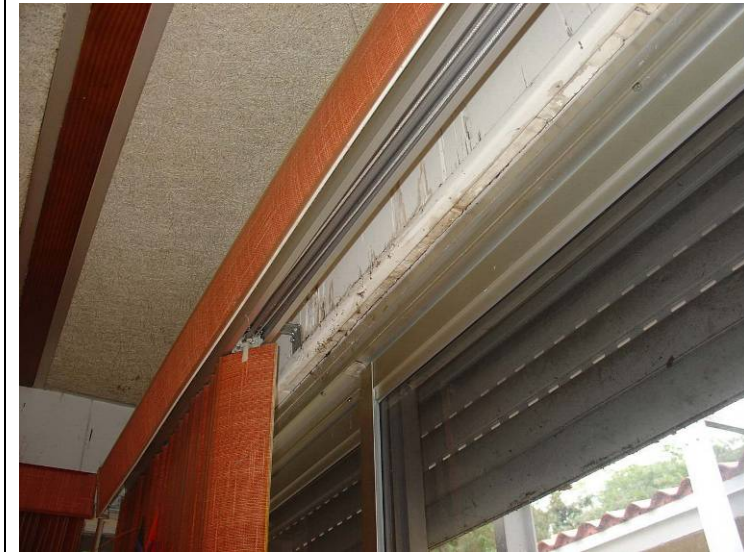
8

26. The living room east sliding glass door is inoperable. 150.00
27. Water stains were noted on the living room terrazzo floor, ceiling panel, and wall above the south sliding glass door. The stains are the result of a roof leak. The listing agent states that repairs were completed in this area. Please see roof section for additional comments.

Water staining on wall above living room sliding glass door.

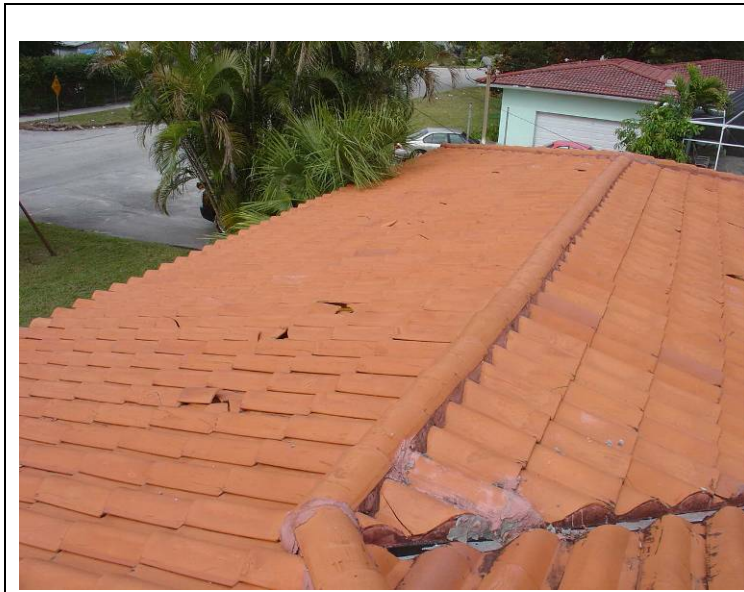
9

1. Approximately 240 tiles were found to be crushed, cracked, or chipped throughout the entire roof. This is typical of damage sustained during fumigation tenting. A section of tiles at the center vent stack were found to be unsecured and out of position.
2. Blisters and uneven sections of the flat roof were noted throughout. The blisters were found to be stiff, indicative of several installed roof membranes. It is possible that the existing flat roof is a recovery roof over one or more previous layers. The membrane has deteriorated as a result of water ponding at the center of the roof. All flat roof layers need to be removed and replaced to provide a smooth and adequately sloped surface.

Crushed and cracked tiles throughout roof. Some repairs noted.

Estimate to repair roofs ... \$9,000.00

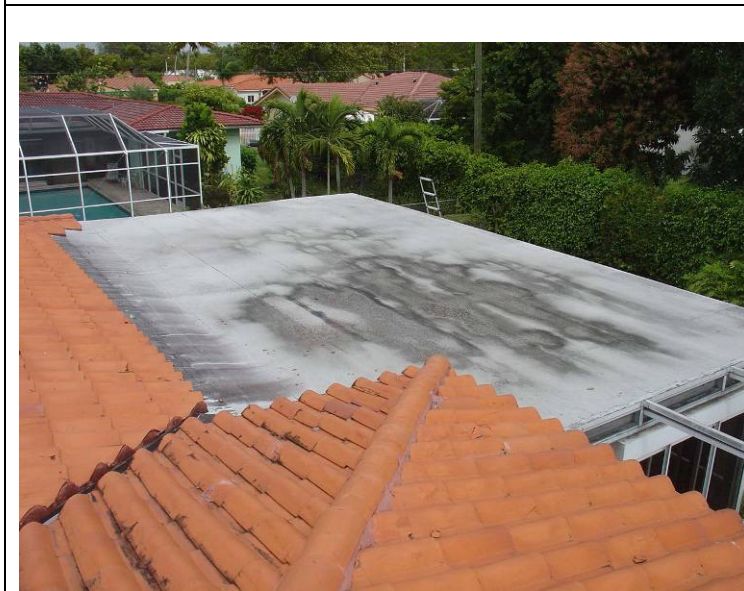
10

Blisters, undulations, and degranulation of the flat roof membrane.

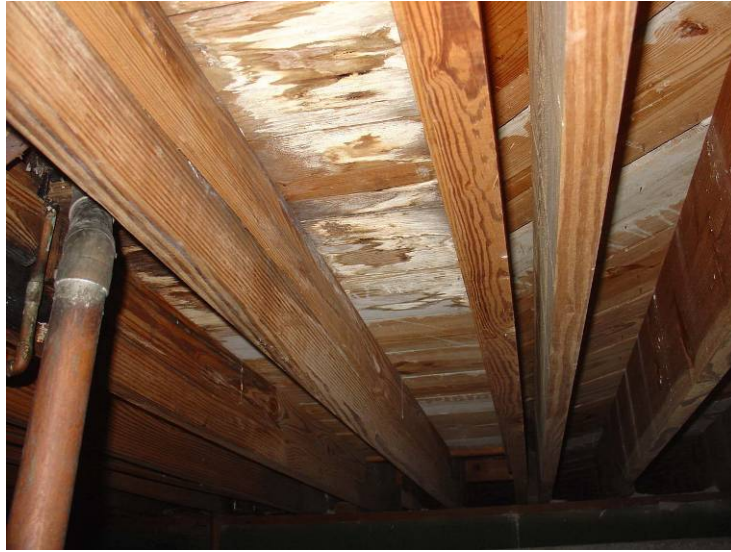
11

3. The crawl space inspection showed the floor structure to be in satisfactory condition at this time. Evidence of white fungal growth was noted on the sub-floor below the bathroom and should be treated with a boric acid solution to prevent wood decay over time. The fungal growth may be the result of concealed plumbing leaks. 800.00

Fungal growth and water stains on the sub-floor below the bathroom. (viewed from within the crawl space)
