# SHEINGOLD & ASSOCIATES, INC

## Building Inspection Report

**Inspection & Report by:** David A. Sheingold, E.I.

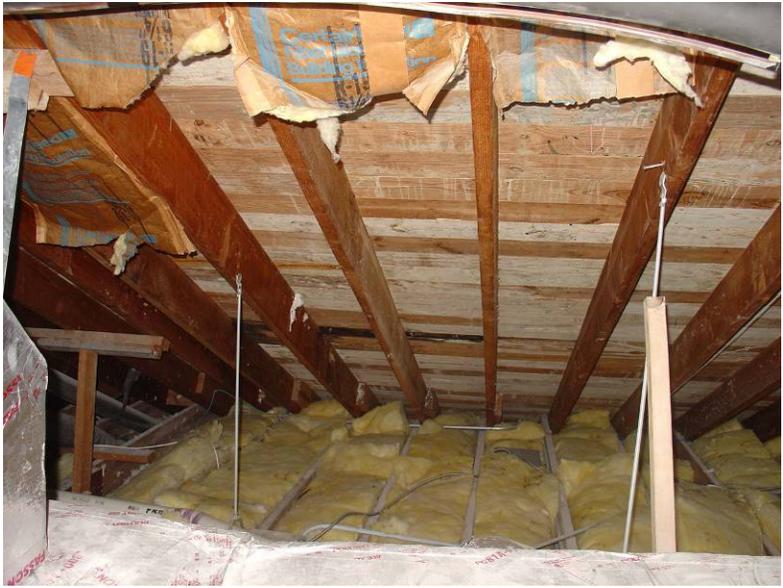
42. The gym entry door fixed door handle is defective.
43. No roof permits were found for the main residence flat cement tile roof. Evidence of previous roof leaks in the form of water stains were noted in the attic but may have since been repaired. The roof has exceeded its typical useful life and repairs have been made to prolong the service life. The roof may require continued repairs in the future until it is replaced.

A photograph of an attic space showing significant water damage. The wooden joists and rafters are stained and discolored. A large area of yellow insulation is visible, and a piece of cardboard is draped over the top of the structure. A wooden board is leaning against the rafters.	<p>1</p> <p>Water staining in attic</p>

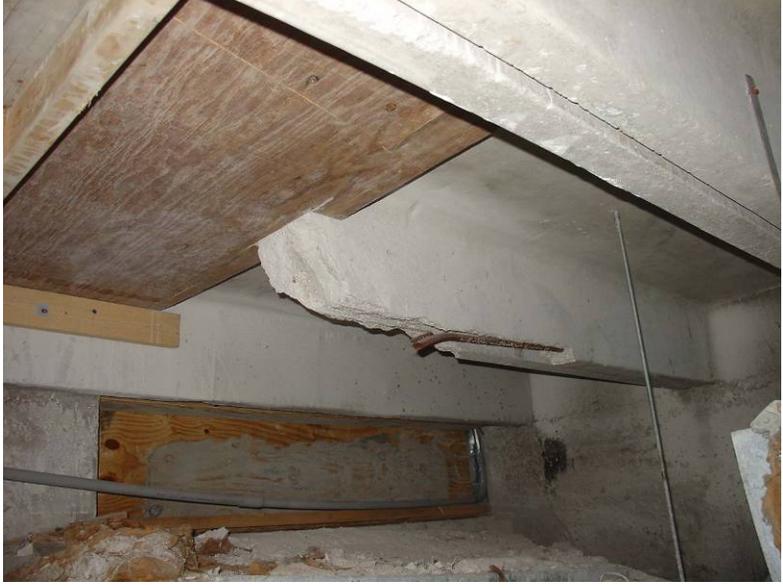
2. The crawl space structure consists of reinforced concrete t-beams. Several T-beam webs have been removed at the east end of the north and central crawl space compartments. The webs are integrated into the slab for structural support and have been replaced with structurally inadequate wood posts. Furthermore, the wood boards conceal the slab soffit which may be structurally damaged. Remove all wood materials and reconstruct T-beam webs and slabs as necessary.

A photograph showing a close-up of a structural T-beam. The web of the T-beam has been removed, leaving a jagged, broken edge. The surrounding area is filled with debris and insulation.	<p>2</p> <p>Removed T-beam web</p>

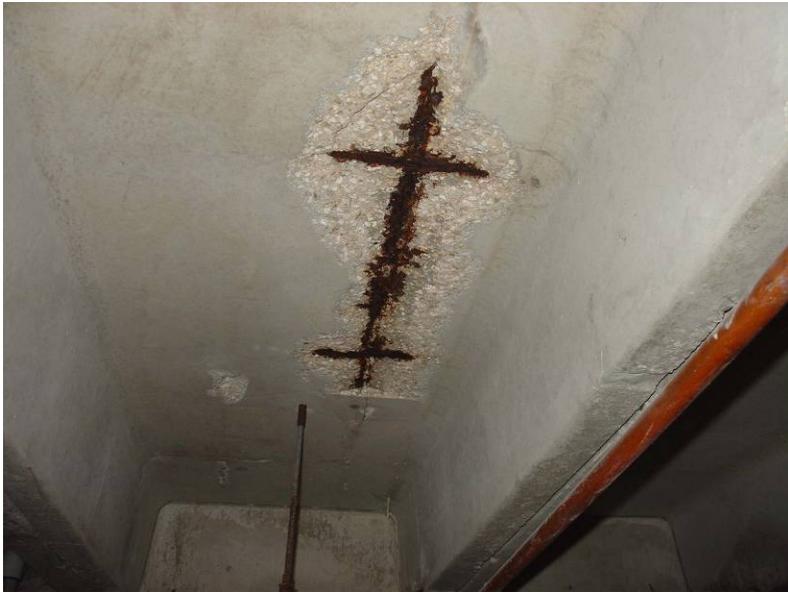
3. The crawl space inspection showed several areas of exposed rebar (spalling) in the north compartment. This compartment corresponds to the rear patio where water has penetrated the surface. We recommend that the patio surface be water proofed or a membrane be installed under the patio tiles to prevent water penetration into the crawl space floor slabs and joists. All damaged concrete members need structural repairs.

<p><b>3</b></p> <p>Spalling on slab soffit</p>

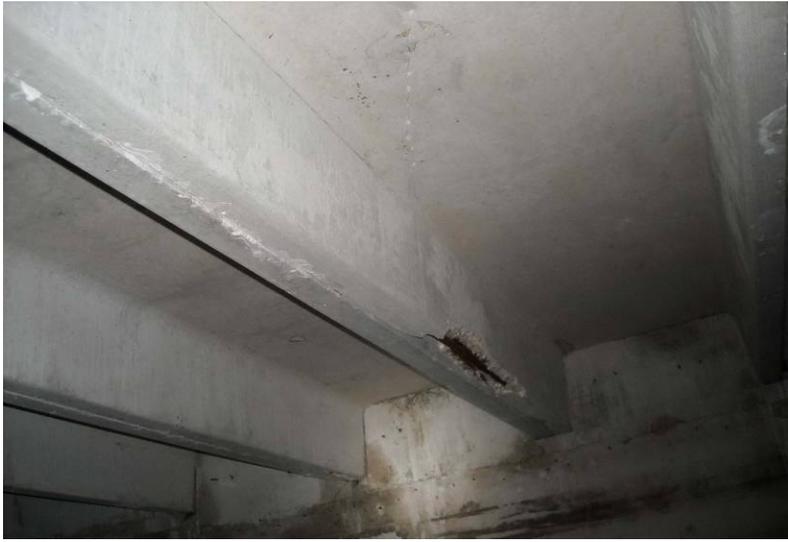
<p><b>4</b></p> <p>Spalling at t-beam web</p>
